LRC Indoor Testing & Research

Re: Limited Fungal and Moisture Evaluation of the Murphy Property Located at 5489 Washington Ferry Road, Montgomery, Alabama with Visual Examination, Moisture Meter Readings, Non-viable Airborne Fungal Spore, Surface Fungal, and Bulk Fungal Sampling Performed on December 4, 2007. Project 07-1017.

Project 07-1017

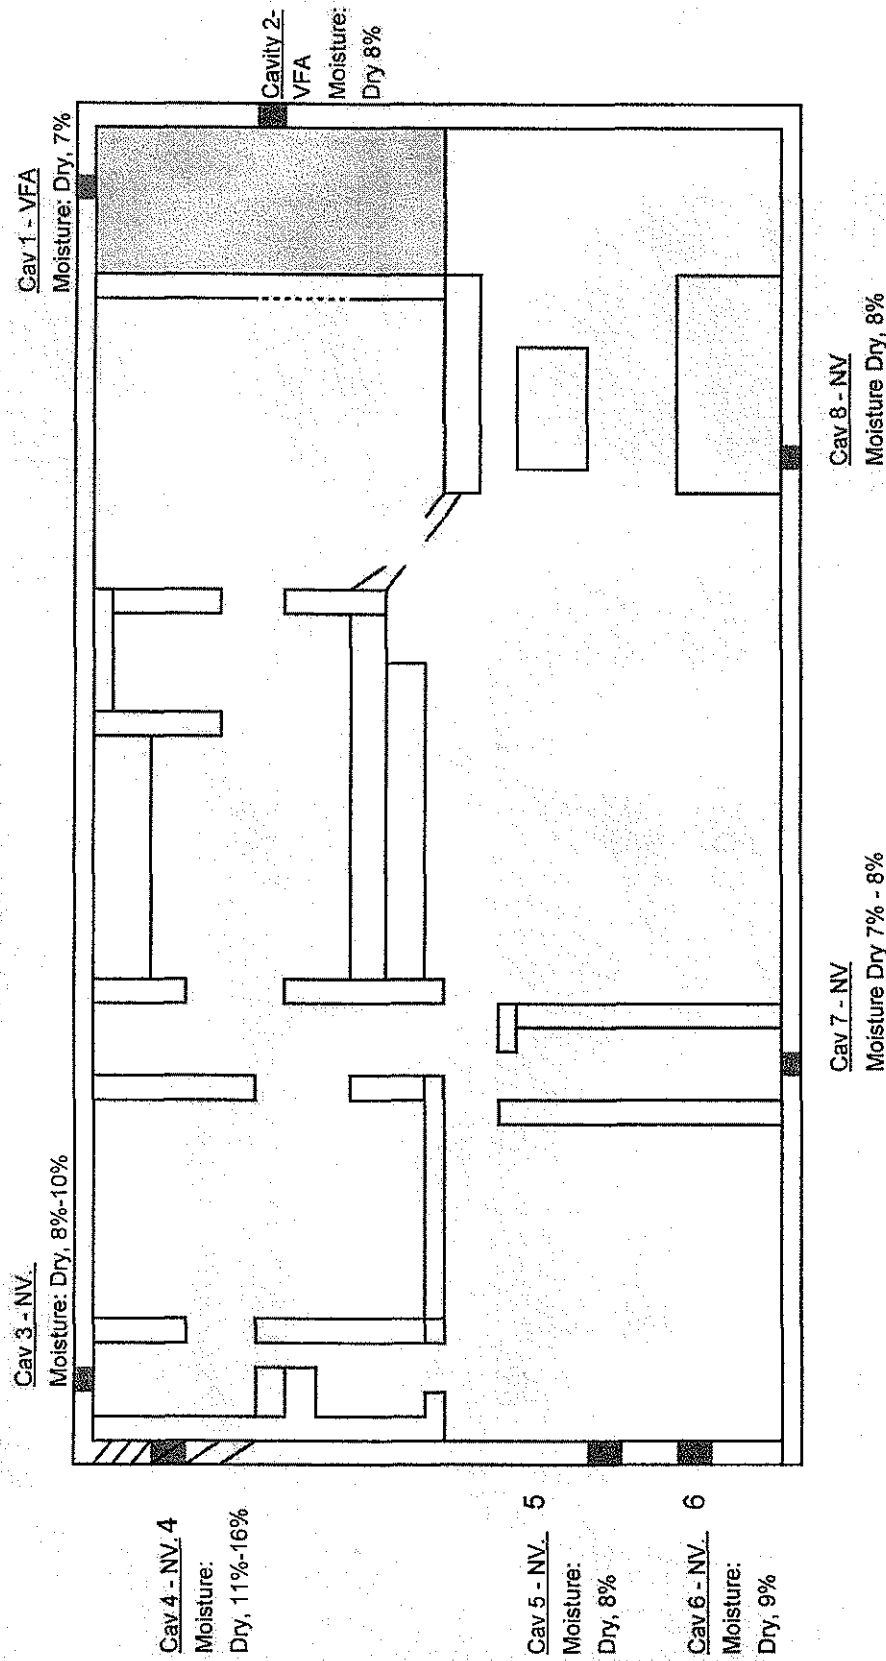
Figure 1. Wall cavity locations and observations at the Murphy house on December 4, 2007. (Drawing not to scale)
PROJECT 07-1017

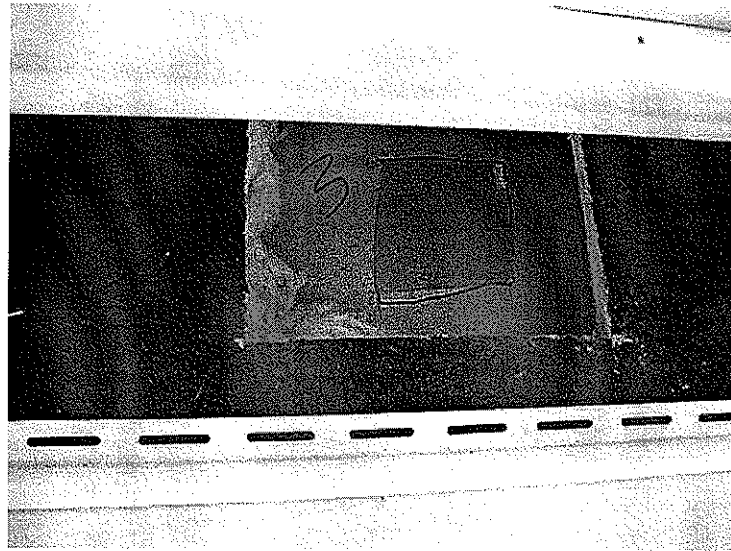
Cavity #3 – The back of the interior wallboard and adjacent wood stud showed no visible evidence of water damage or fungal amplification and penetrating moisture meter readings were in the dry range from 8% to 10%. Tape lift results from the wallboard (Sample 6) showed only low *Penicillium* / *Aspergillus* group spores with no evidence of fruiting structures, suggesting only settled spores. Insulation results (Sample 7) showed only low *Penicillium* / *Aspergillus* group spores and rare *Cladosporium* spores with no evidence of fruiting structures, suggesting only settled spores. Sampling results confirmed visual observations of a Condition 1 as described above in Cavity #3.

Wall Cavity #3 – Normal freckled paper wallboard with no visible fungal amplification, water damage, or degradation and dry moisture content measured pronged at 8% to 10%.

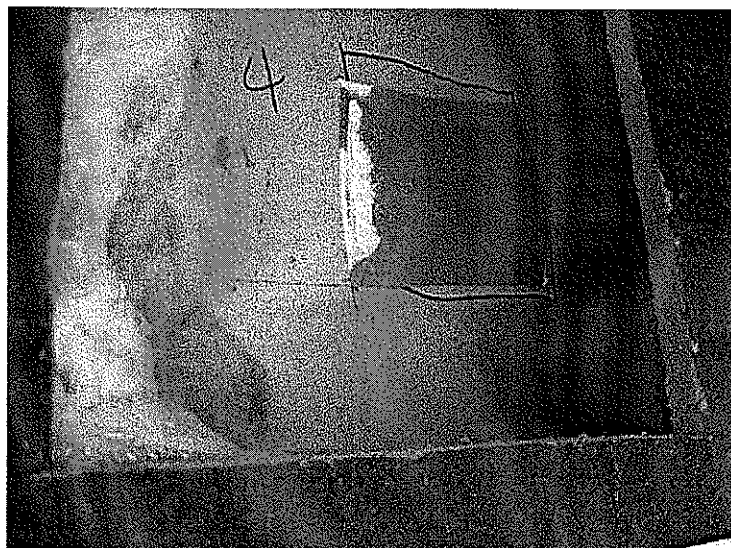
Cavity #4 – The back of the interior wallboard and adjacent wall stud showed no visible evidence of water damage or fungal amplification and the penetrating moisture meter reading on the wood was 0% and the wallboard was in the dry range at 11% to 16% in the non-penetrating mode and 9% in the penetrating mode. Tape lift results (Sample 8) showed only no detectable spores present. Insulation results (Sample 9) also showed no detectable spores present. Sampling results confirmed visual observations of a Condition 1 as described above in Cavity #4.

Wall Cavity #4 – Normal freckled paper wallboard with no visible fungal amplification, water damage, or degradation and moisture content measured dry at 11% to 16% non pronged.

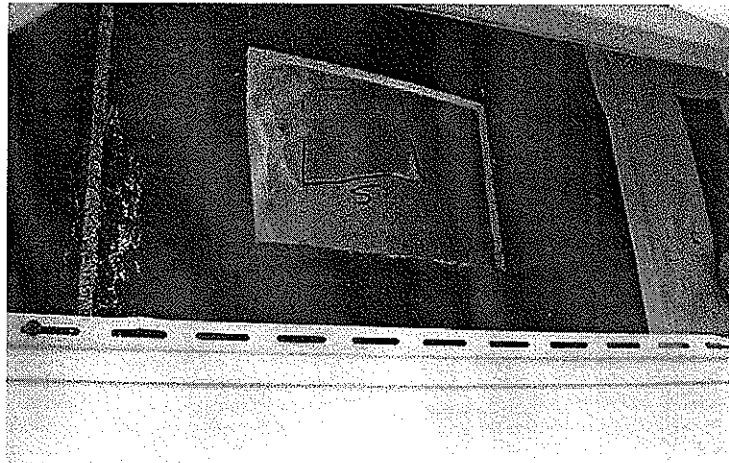
Cavity #5 – The back of the interior wallboard showed no visible evidence of water damage or fungal amplification and the penetrating moisture meter was in the dry range at 8%. Tape lift results (Sample 12) showed only medium *Penicillium* / *Aspergillus* group, low *Cladosporium* spores and rare *Curvularia* spores with no evidence of fruiting structures, suggesting only settled spores. Insulation results (Sample 13) showed no detectable spores. Sampling results confirmed visual observations of a Condition 1 as described above in Cavity #5.

Wall Cavity #5 – Normal freckled paper wallboard with no visible fungal amplification, water damage, or degradation and moisture content measured dry pronged at 8%.

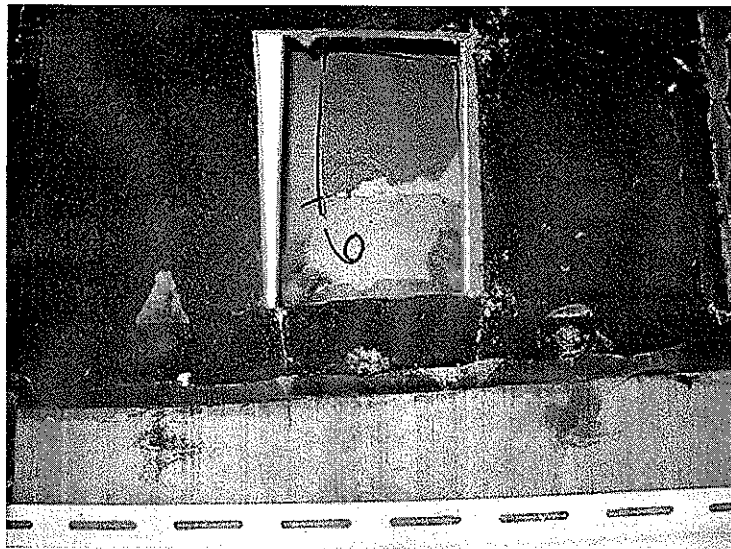
Cavity #6 – The back of the interior wallboard showed no visible evidence of water damage or fungal amplification and the penetrating moisture meter was in the dry range at 9%. Tape lift results (Sample 14) showed only rare *Penicillium* / *Aspergillus* group spores and Basidiospores with no evidence of fruiting structures, suggesting only settled spores. No insulation was taken from cavity #6. Sampling results confirmed visual observations of a Condition 1 as described above in Cavity #6.

Wall Cavity #6 – Normal freckled paper wallboard with no visible fungal amplification, water damage, or degradation and moisture content measured dry pronged at 9%.

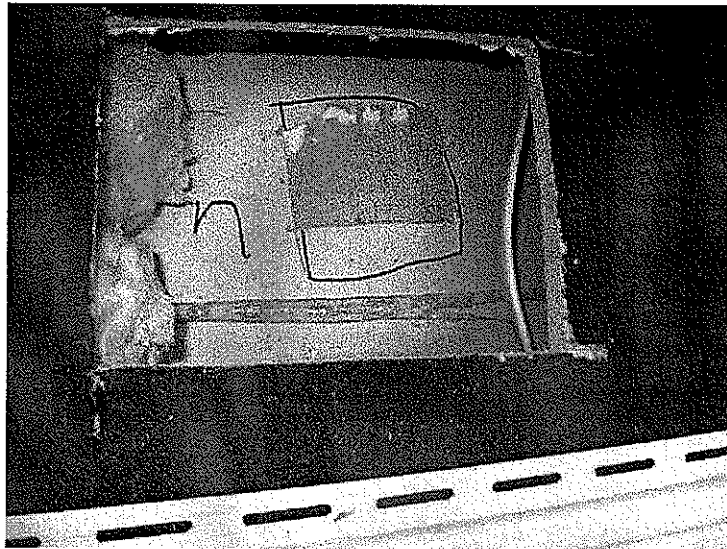
Cavity #7 – The back of the interior wallboard showed no visible evidence of water damage or fungal amplification and the penetrating moisture meter was in the dry range at 7% to 8%. Tape lift results (Sample 16) showed only low *Penicillium* / *Aspergillus* group spores with no evidence of fruiting structures, suggesting only settled spores. Insulation results (Sample 17) showed no detectable spores. Sampling results confirmed visual observations of a Condition 1 as described above in Cavity #7.

Wall Cavity #7 – Normal freckled paper wallboard with no visible fungal amplification, water damage, or degradation and moisture content measured dry, pronged at 7% - 8%.

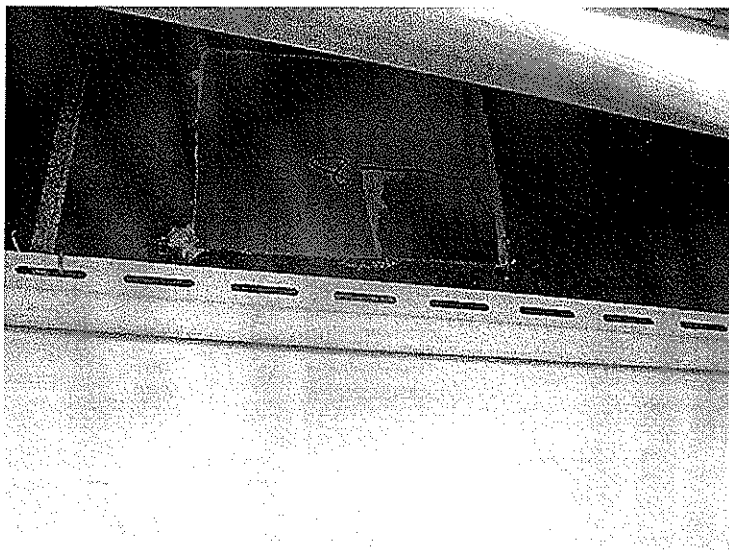
Cavity #8 – The back of the interior wallboard showed no visible evidence of water damage or fungal amplification and the penetrating moisture meter was in the dry range at 8%. Tape lift results (Sample 18) showed no detectable spores. Insulation results (Sample 19) also showed no

detectable spores. Sampling results confirmed visual observations of a Condition 1 as described above in Cavity #8.

Wall Cavity #8 – Normal freckled paper wallboard with no visible fungal amplification, water damage, or degradation and moisture content measured dry, pronged at 8%.

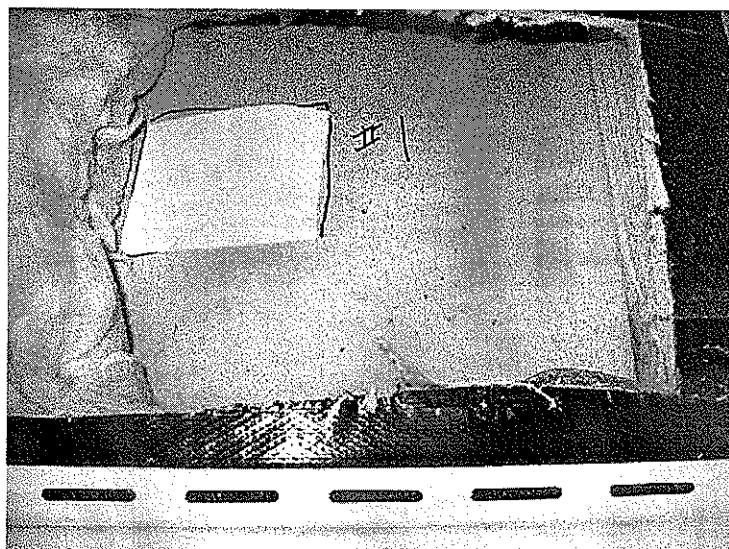
Cavity #1 – Cavity # 1 was associated with the end-wall of the master bathroom and was observed both above 5-feet and at or near ground level due to homeowner reports of a previous plumbing leak in the master bathroom. Above 5-feet, visible fungal amplification was observed in the form of a darkened area approaching several square inches. Areas of wallboard around the darkened area appeared clean. A tape lift of the darkened patch (Sample 20) showed high levels of *Penicillium* / *Aspergillus* group spores with low levels of *Cladosporium* spores. While the area was currently dry at 8%, visual observations and sample results confirmed a Condition 2 or 3 as described above where the wallboard was darkened. A sample was taken from visibly clean wallboard next to the darkened area (Sample 22) that showed only low *Penicillium* / *Aspergillus* group spores and medium *Cladosporium* spores, suggesting a Condition 1 as described above. Insulation results (Sample 21) showed medium *Penicillium* / *Aspergillus* group spores and rare *Cladosporium* spores, suggesting a Condition 1 or Condition 2 due to the proximity to the darkened area as described above. At or near ground level, no visible fungal amplification was observed in Cavity #1.

Wall Cavity #1 Master Bathroom – Normal freckled paper wallboard with mostly no visible fungal amplification, water damage, or degradation and moisture content measured dry, pronged at 8%. A small darkened area just above the “#1” was sampled (Sample #20) and showed high *Penicillium* / *Aspergillus* (P/A), and the normal appearing main sections (Sample 22) showed low P/A spores.

In the master bathroom, localized fungal amplification was observed in the wall cavities due to the previously reported water damage from a broken pipe. It is recommended that the master bathroom back and side walls be thoroughly investigated and remediated by an IICRC or ASCR certified mold remediation company. This should be done using investigative demolition as outlined below. All remediation procedures should follow the guidelines as outlined in the IICRC S520 *Standard and Reference Guide for Professional Mold Remediation* and the remediation should be performed as such while protecting workers, occupants, contents, and the indoor spaces from disturbed dusts and associated components such as fine particulate matter and mold spores.

2. Any HVAC supply registers or return grills if present in the contained area should be covered with polyvinyl plastic.
3. Contaminated and/or water damaged porous wall materials in the bathroom should be removed, double bagged in polyvinyl bags and removed from the containment. Any wallboard materials with fungal amplification should be removed 24" beyond visible contamination. Remaining hard surfaced materials that show fungal amplification should be HEPA-vacuumed, and cleaned by scraping, sanding, or other means such as soda or carbon dioxide blasting and HEPA-vacuuming, and dried to appropriate levels. Any materials that are deemed to have lost structural integrity should be removed and replaced. After cleaning and drying, an appropriate biocide or sealant may be used after a clearance evaluation.

4. After cleaning and remediation in the master bathroom area surface and air clearance testing is recommended.

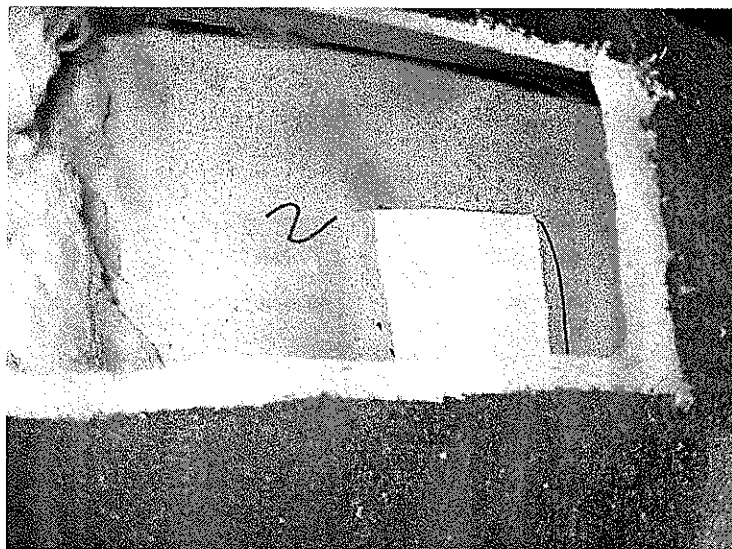
Cavity #2 – Cavity # 2 was associated with the back wall of the master bathroom and was observed above 5-feet on this occasion, and as in Cavity #1, the homeowner reported a previous plumbing leak in that location. At approximately 5-feet, visible fungal amplification was observed on the wallboard. A photograph from a previous investigator supplied to me showed an obvious water stain on the wallboard at or near the floor level. A tape lift of the visible fungal amplification (Sample 23) showed high levels of *Penicillium* / *Aspergillus* group spores with low levels of *Cladosporium* spores and rare *Chaetomium* spores. Insulation results (Sample 24) showed no detectable spores. While the area was currently dry at 8%, visual observations and sample results confirmed a Condition 3 as described above in wall Cavity #2.

Wall Cavity #2 Master Bathroom – Normal freckled paper wallboard with visible fungal amplification and no water damage at 5 feet, and moisture content measured dry, pronged at 8%.

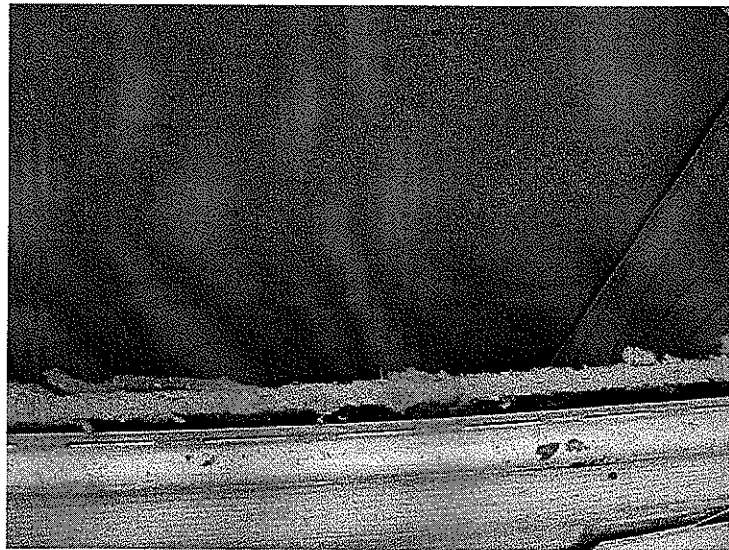
Wall Cavity #2 Master Bathroom – Normal freckled paper wallboard with visible fungal amplification and water damage at floor level.
